Ref ZG2024/0183/FUL: Infilling of Rudgate bridge, nr Newton Kyme

We are writing to object to the above planning application which seeks permission to retain infill at the bridge carrying Rudgate over the dismantled Church Fenton-Harrogate railway near Newton Kyme, North Yorkshire.

Project:	HRE Assessment Programme		
Client:	HE-HRE	Project Number:	B28280BT
Document Title:	CFH1/12 BD21 Assessment and Inspection Report		
Doc. No:	0450380

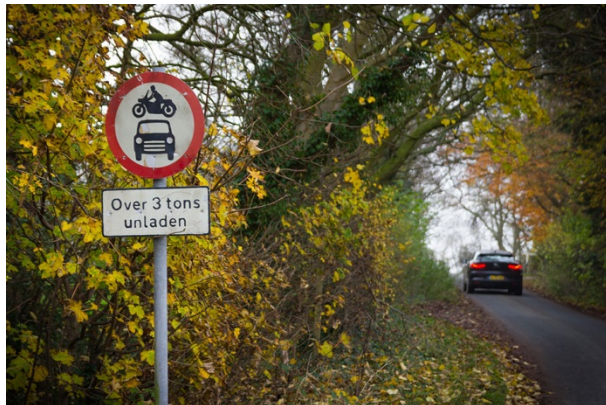
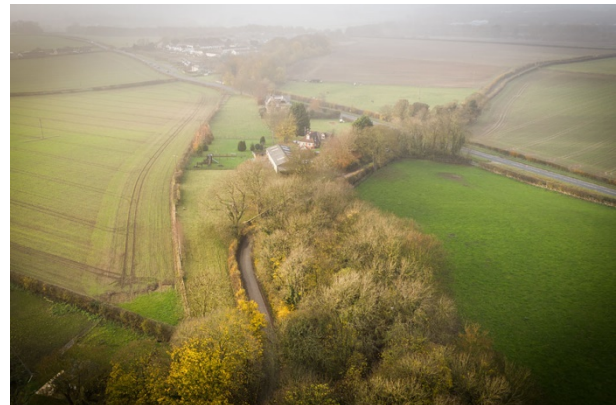
At the junction with the A659, 100m from the structure, a sign indicates that Rudgate is prohibited to motor vehicles of “over 3 tons unladen”. There is doubt as to the legal status of this restriction; however, the sign is the means of communicating it, upon which the driver acts. It is unlikely that a driver would choose to disregard the sign on the basis that, in their opinion, the restriction was non-compliant and/or unenforceable.

The sign at Rudgate's junction with the A659 and (right) an aerial view of the bend at the bridge's south end.

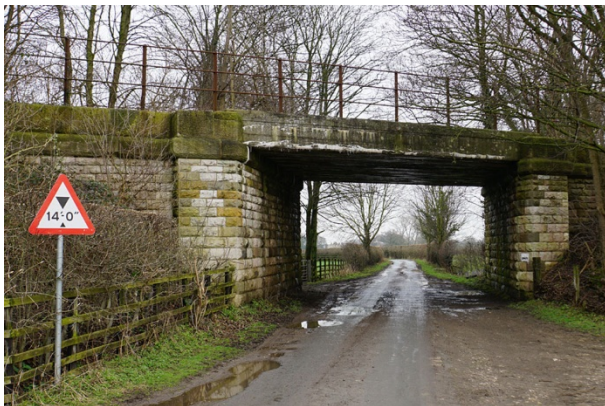
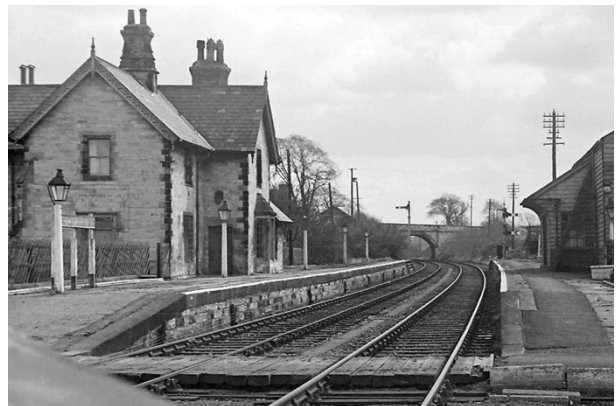
Watson's Lane bridge (Bill Boaden) and a view of Newton Kyme's former station house, with Rudgate bridge in the background (Tadcaster Historical Society).

Also in the PS, National Highways asserts that "There are no other remaining physical elements of the former Church Fenton to Harrogate Railway Line near the bridge itself...". This statement fails to recognise the cutting on its east side, the underbridge at Watson's Lane, 320m to the south-east (albeit with a replacement concrete span) and Newton Kyme's former station house, 200m north-west.

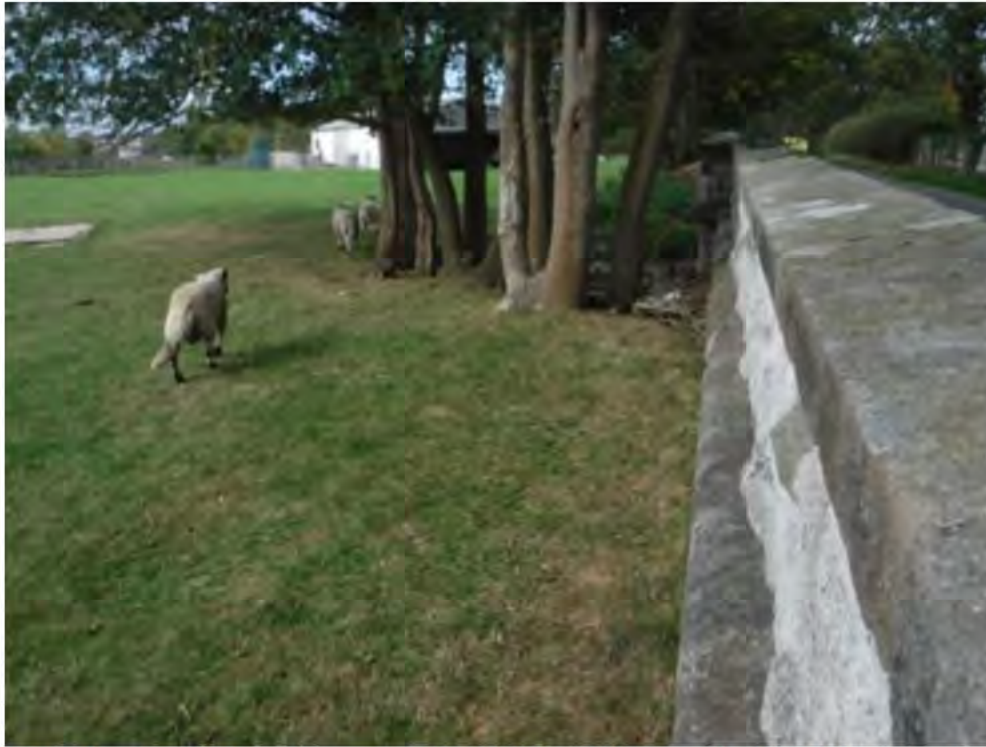
Severe Defects - Mature tree growth within the proximity of the structure. P1.

Photo No: 1 – Mature tree growth: Within of the proximity of the structure.

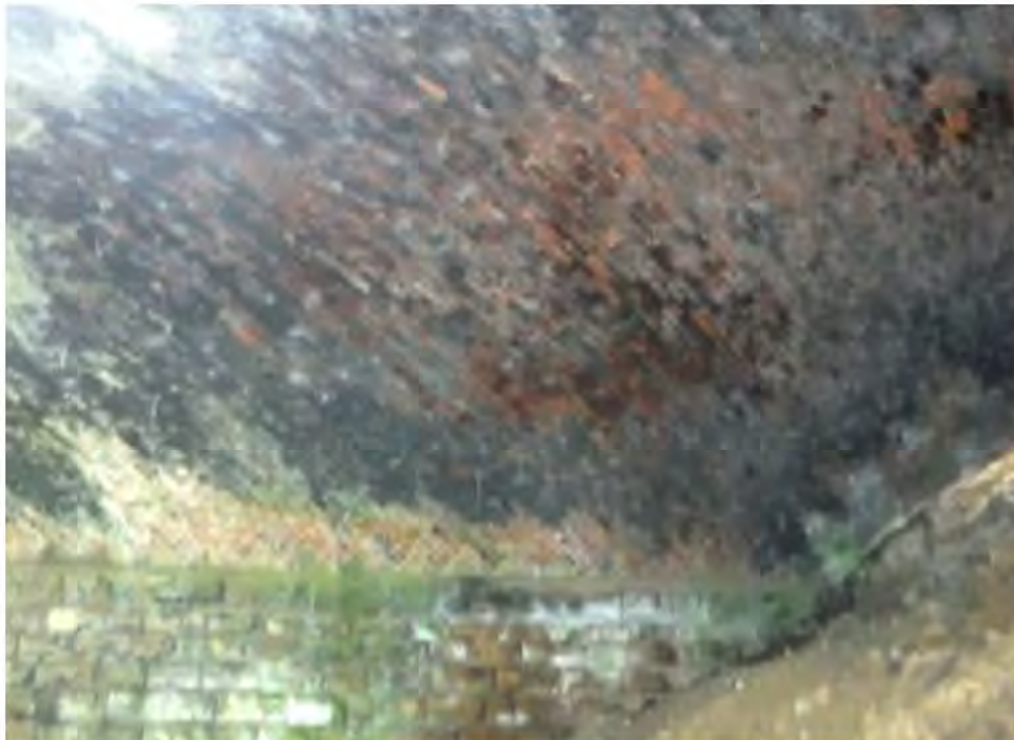
In relation to existing defects, the examiner who conducted the 2018 inspection stated that there is "*Possible* further deterioration to the spalling brickwork areas, *possible* further deterioration to the eroded stonework areas also the vegetation is progressively getting worse. P2 to P4."¹

Photo No: 2 – Possible further deterioration: To the spalling brickwork areas.

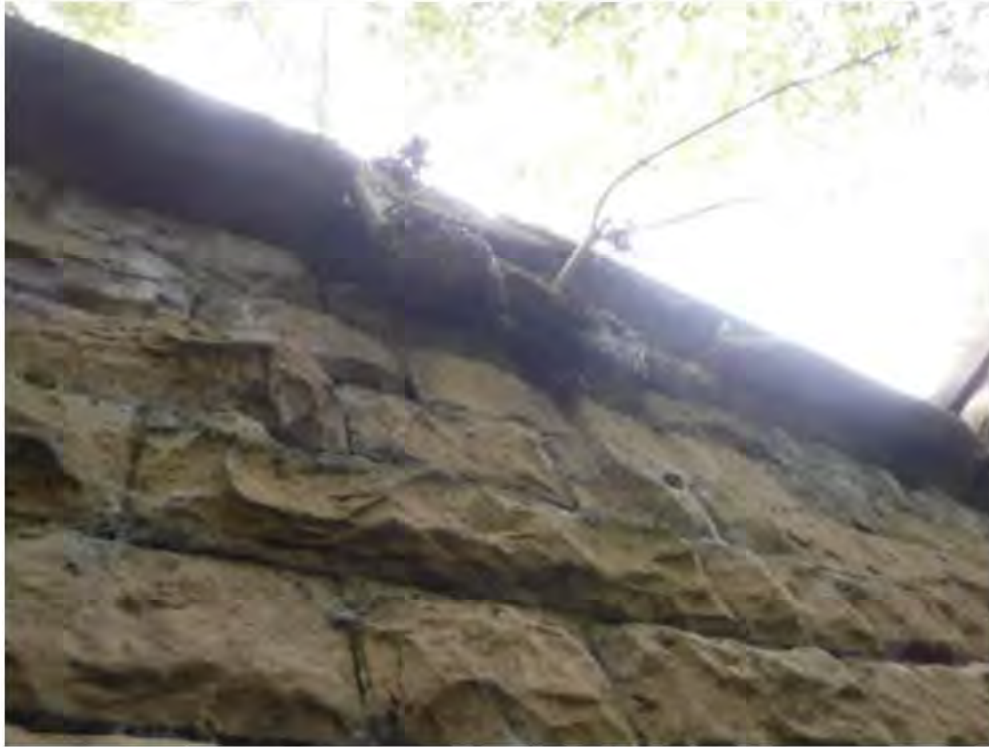
Photo No: 3 – Possible further deterioration: To the eroded stonework areas.

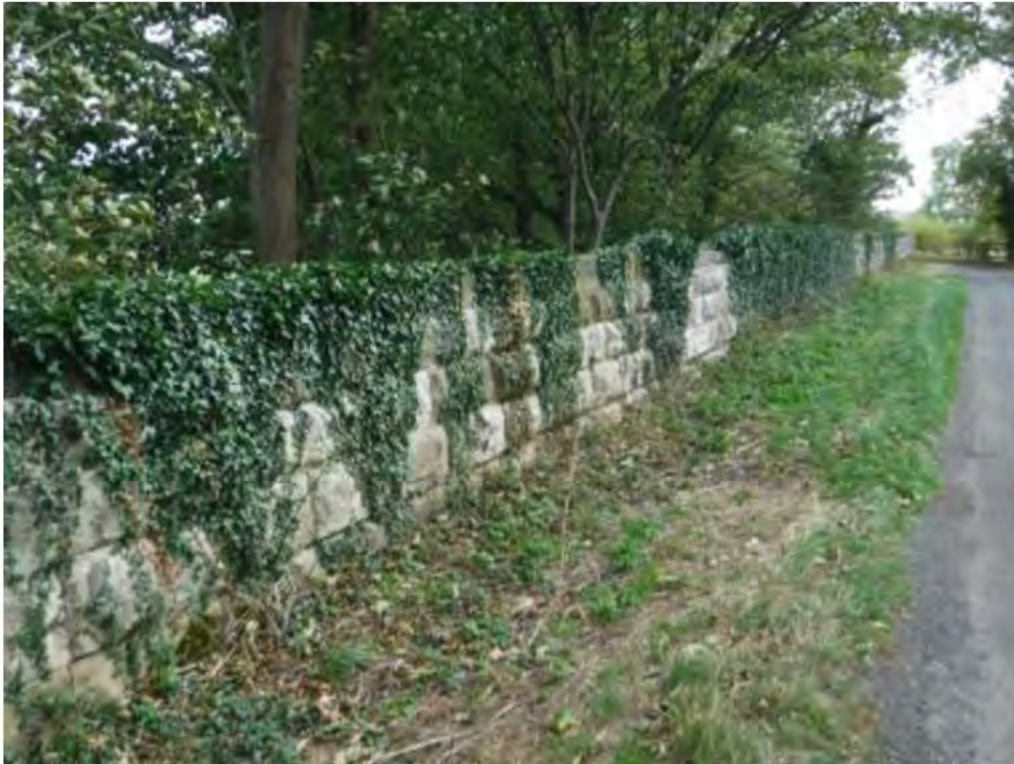
Photo No: 4 –Vegetation: Progressively getting worse.

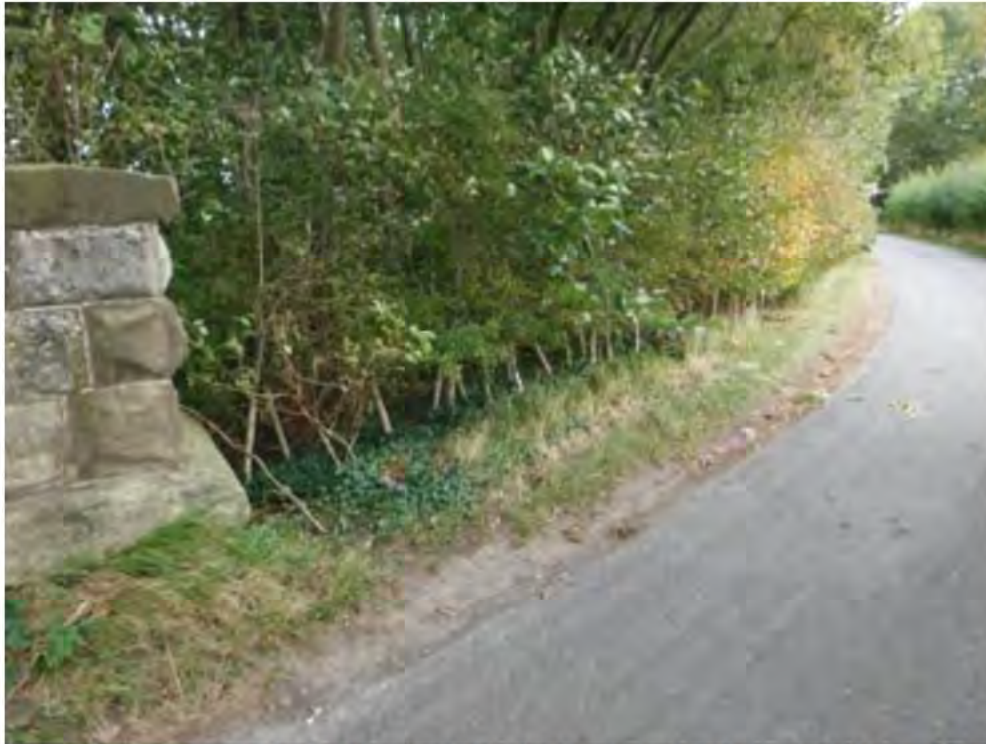
Photo No: 5 – Approach road fencing: Typical example of the condition at S/E end.

The examiner's only recommendation was to spend £1K repairing or renewing approach fencing to the south-east. No requirement for structural works was identified. However, on the appended risk matrix, National Highways' engineer asserts "infilling preferable to repairs" and, under Action/Notes, states "Case to be made for infilling".

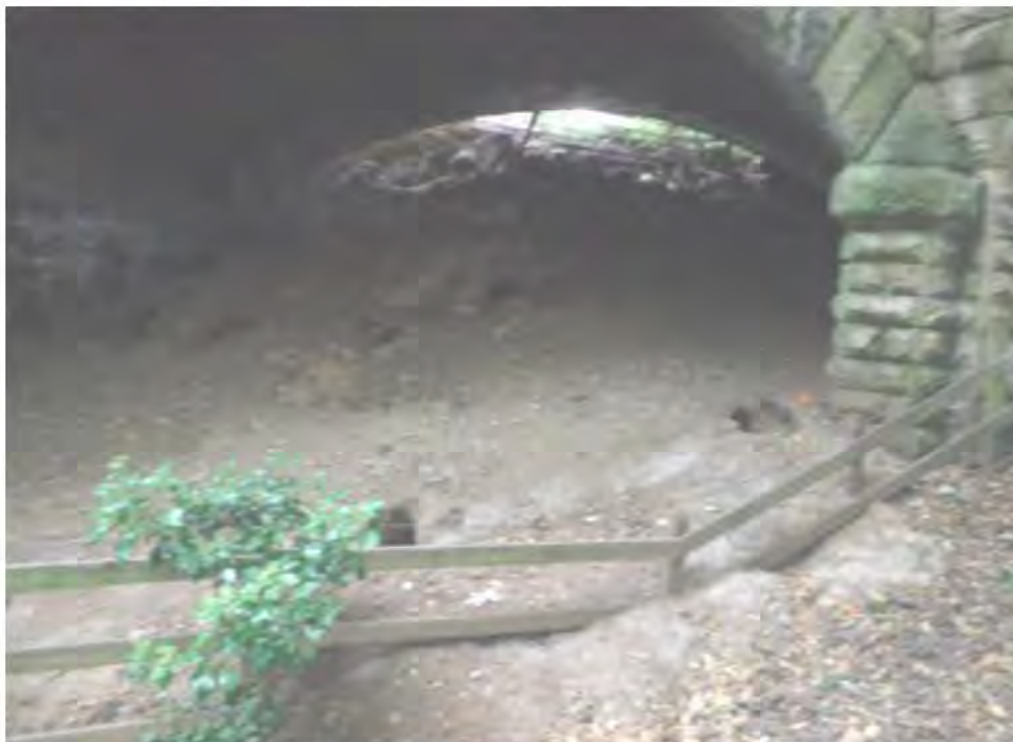
Photo No: 6 – Area under the structure: Typical example.

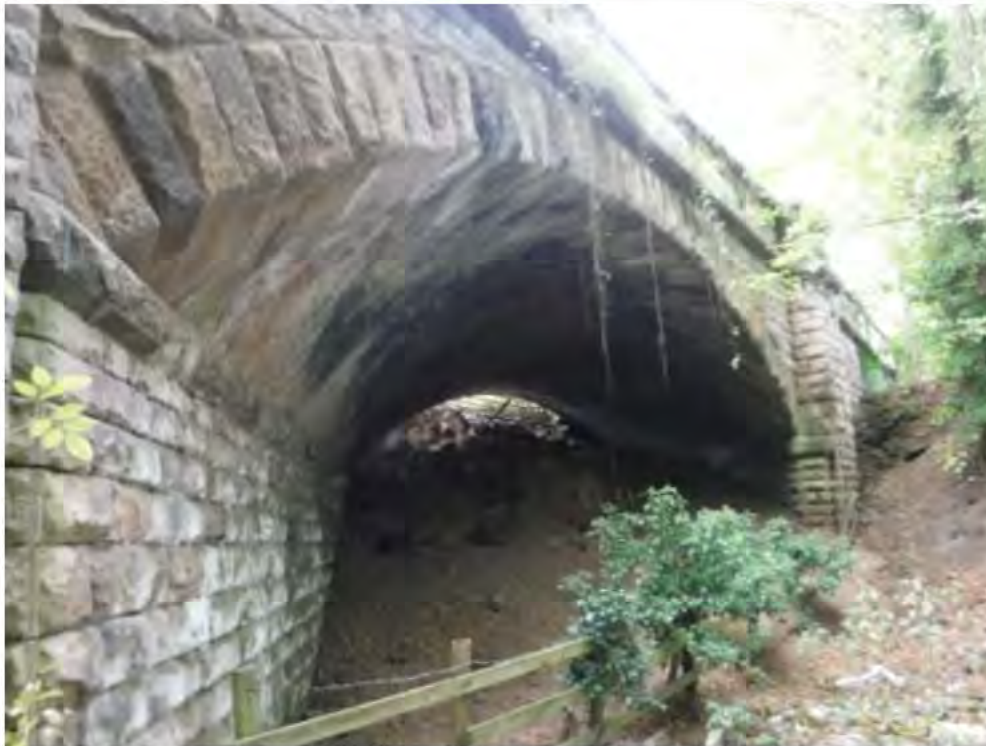
Photo No: 7 – Arch ring soffit: View.

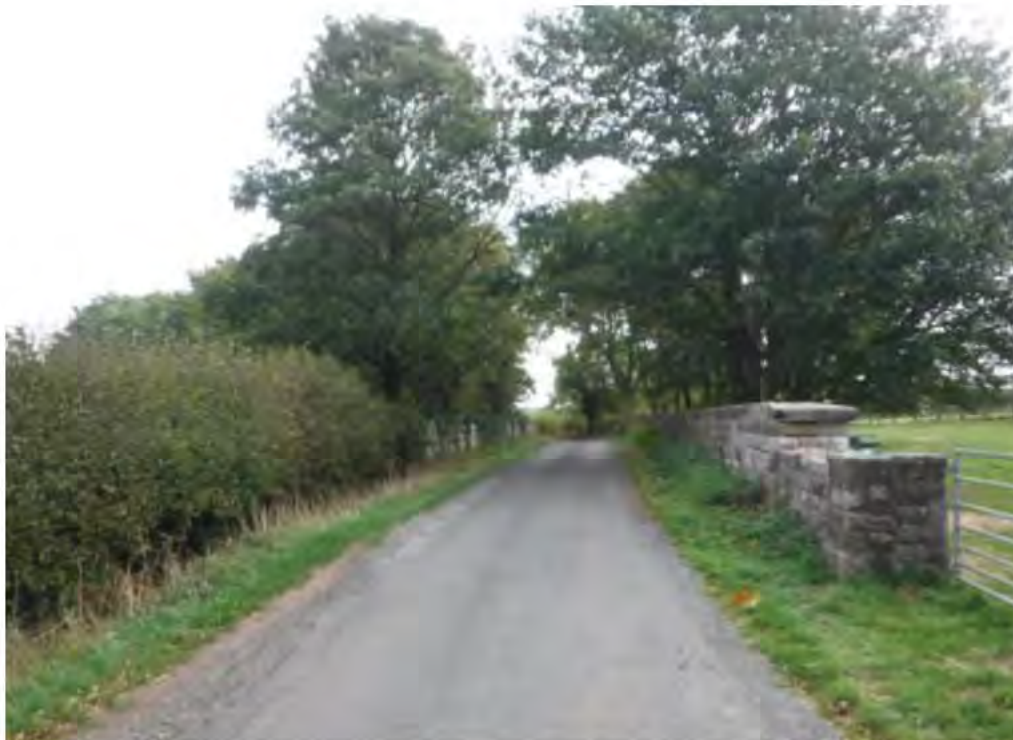
Photo No: 8 – View: Across Structure.

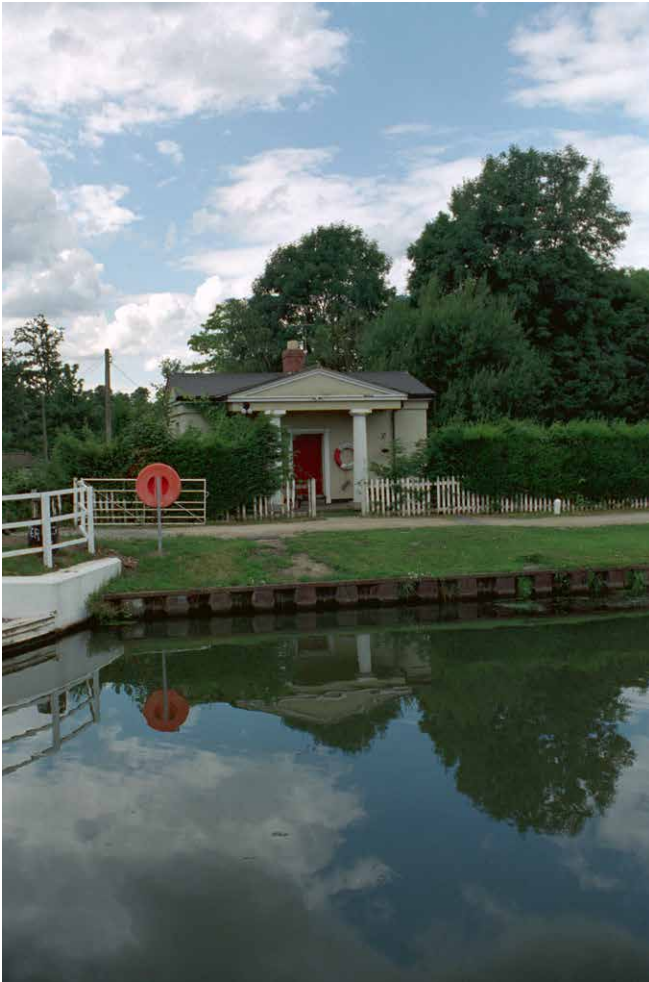
Figure 1
 Bridgekeeper's House, Fretherne Bridge, Fretherne, Gloucestershire. One of a series of classically-inspired houses along the Gloucester-Sharpness canal of the early nineteenth century. Probably designed by Robert Mylne who had acted as Surveyor to the company in 1793. A high degree of architectural interest and individuality is given to what is more usually an unremarkable building type. Listed Grade II.

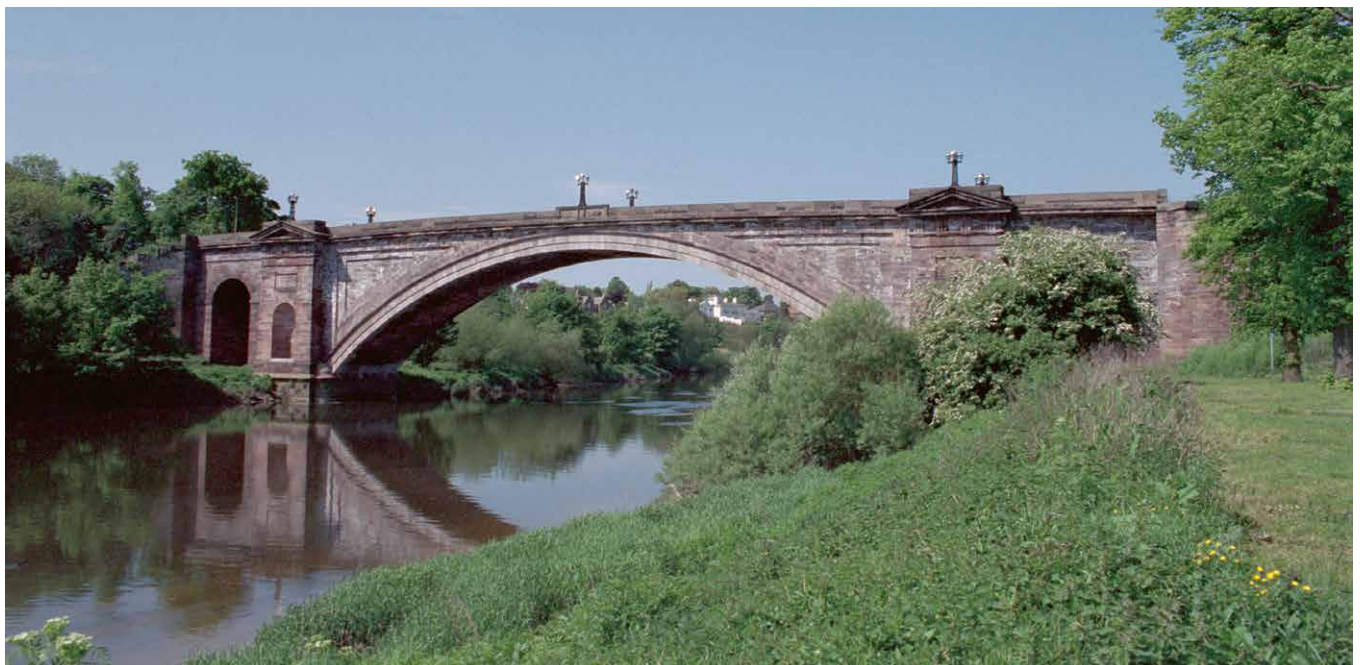
Figure 2
Grosvenor Bridge, Grosvenor Road, Chester. When designed in 1824 by Thomas Harrison the 200-foot single span of the Grosvenor Bridge was one of the

longest in the world. The architect took care to provide separate passage for pedestrians and coaches at riverbank level. Listed Grade I.

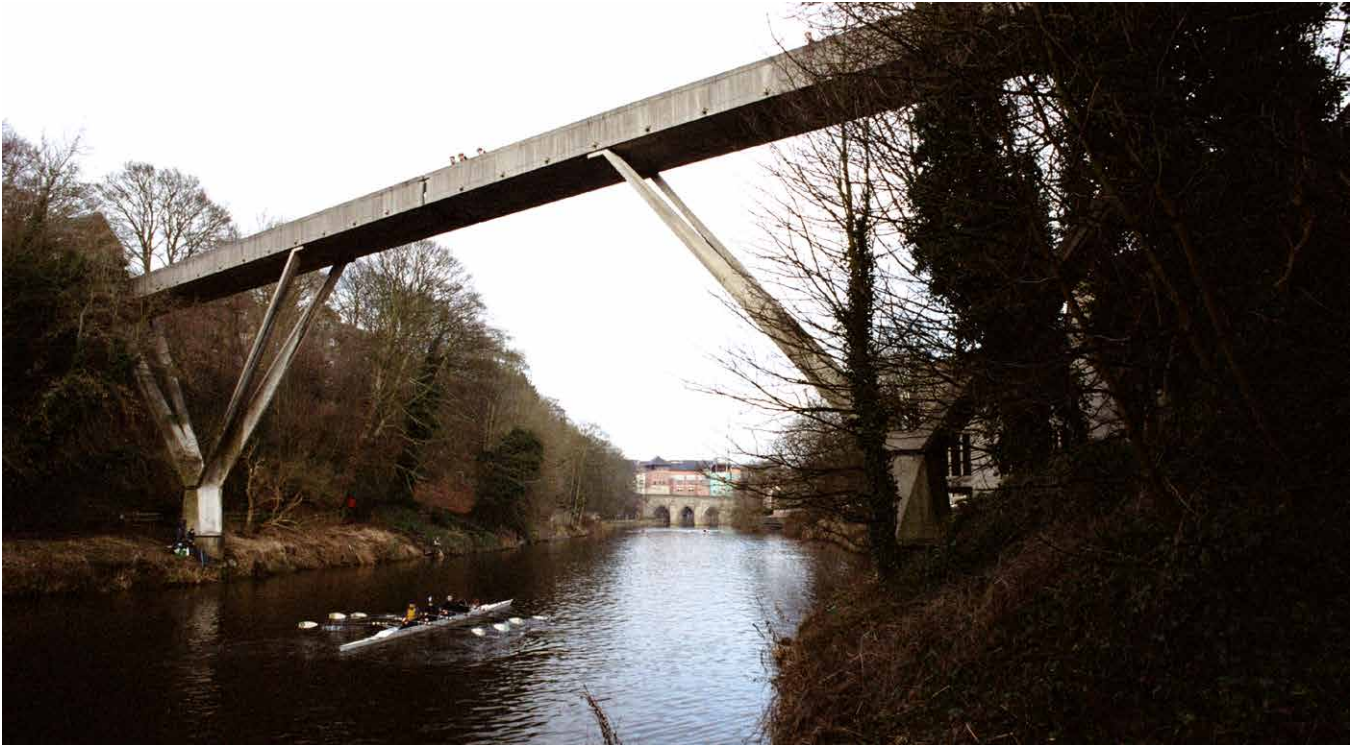
Figure 3

A slender concrete footbridge to unite town and gown in the ancient cathedral city of Durham. Designed by Sir Ove Arup in 1963, its dramatic silhouette is

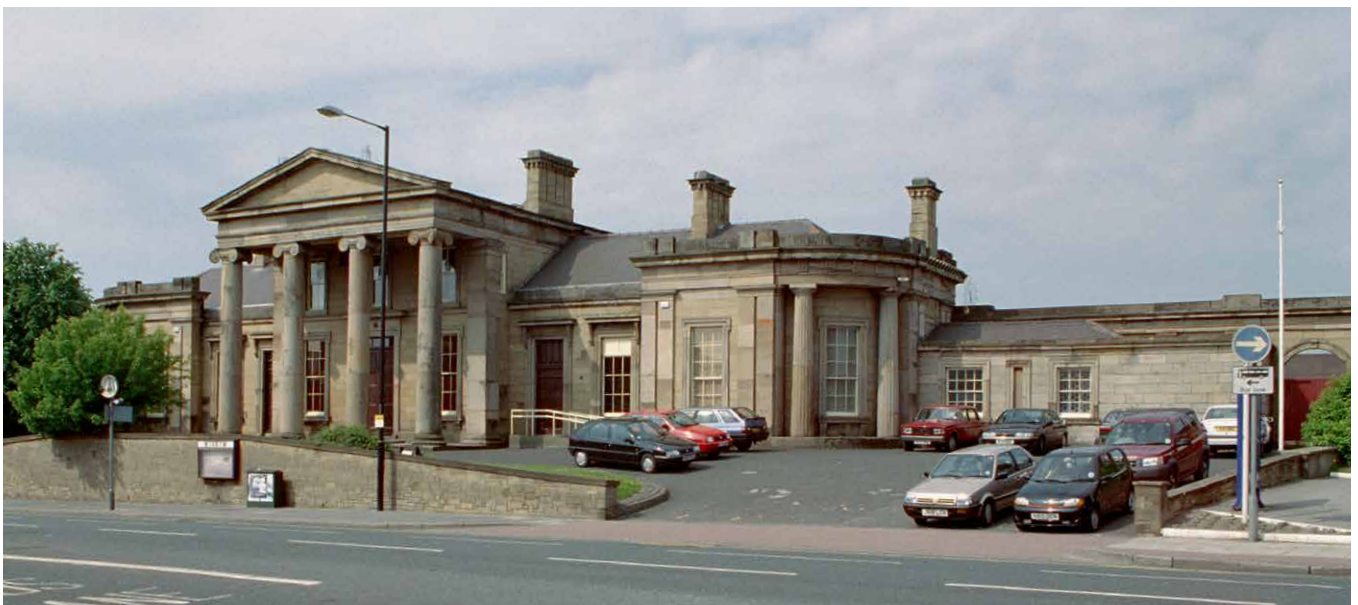
Figure 4
The former Monkwearmouth railway station, Sunderland, designed for the York, Newcastle and Berwick Railway Co. in 1848. A building of considerable dignity now used as a museum following closure of

the line. It retains much of its interior and the listing includes a later cast-iron footbridge attached to the rear of the station. Listed Grade II*.

These are among the icons of the modern industrial age (Fig 4). The first surviving example in the world is the former Liverpool Road railway station (and station master’s house), Manchester, of 1830 (listed Grade I), designed by George Stephenson and resembling a terrace of smart town houses. The great termini and city stations were elaborate structures with massive train sheds that spanned several platforms and were fronted by prestigious hotels (see the [Commerce and Exchange Buildings](#) selection guide). Most are listed, sometimes at a high grade. By contrast, minor stations and other wayside buildings built pre-1850 were often quite plain and modest in their design. Multi-

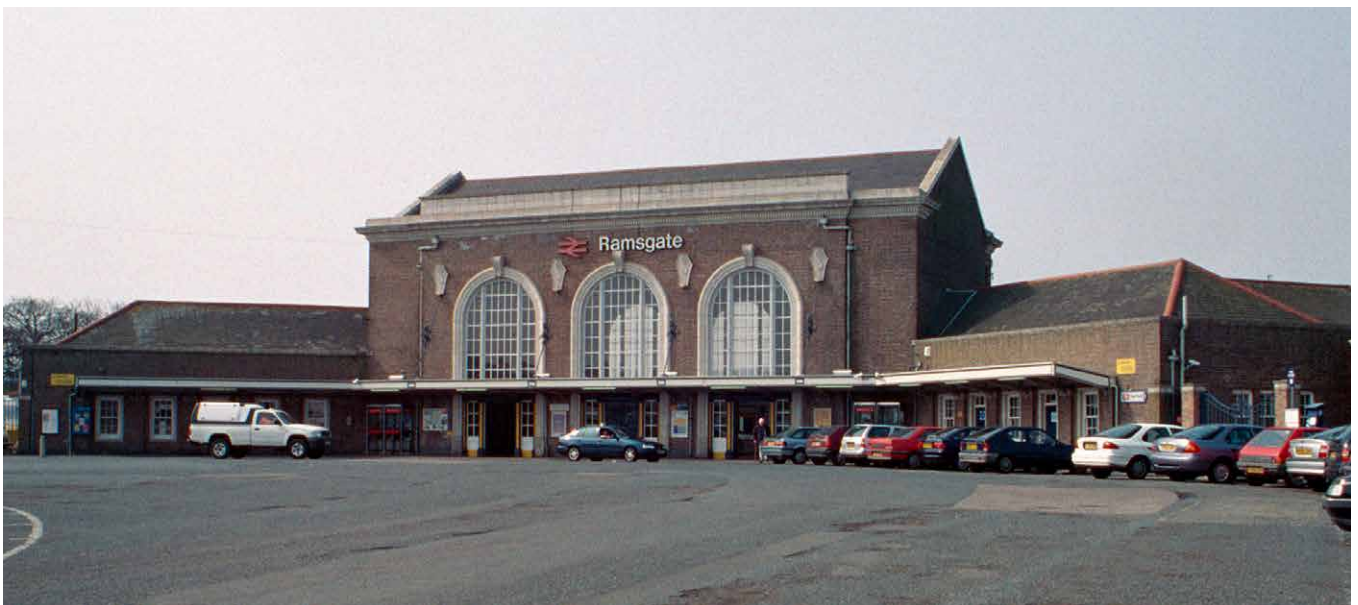
Figure 5
Ramsgate Railway Station, Kent. An unusual foray for railway station architecture into the neo-Georgian style and designed to resemble an enormous orangery or garden building. A notable early work (1924-6) by one

of the later proponents of the Modern Movement in England, E Maxwell Fry, acting as chief assistant to J R Scott, the Southern's Chief Architect. Listed Grade II.

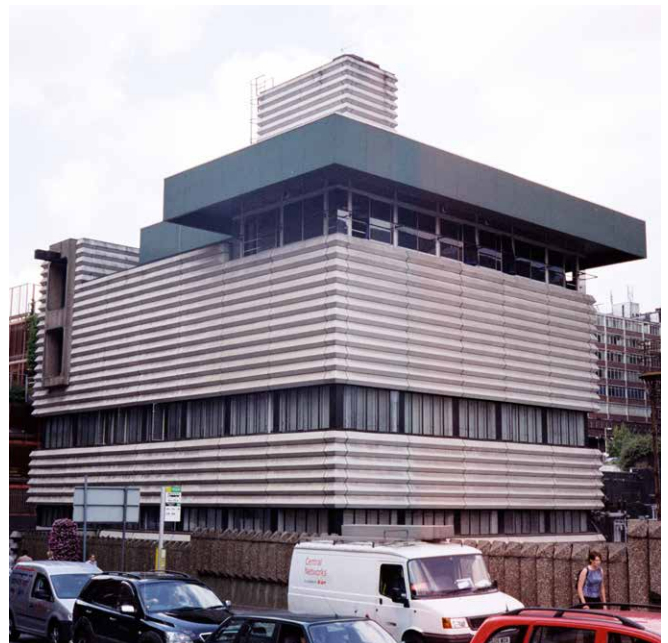
Figure 6
Birmingham New Street Signal Box, Navigation Street, Birmingham. A dramatic tour-de-force of the Brutalist style, opened in 1964, which gave the railway signal box typology a new lease of life in post-war England. Making clever use of a difficult site the architects Bicknell and Hamilton (with R L Moorcroft) created a building at once functional and iconic. Listed Grade II.
